Weekly Construction Report

Hatchery Creek Design/Build Project

Time Period (two weeks):	June 21 – July 3, 2015	Project No:	1305
Rain Days/Weather Conditions:	It has been a wet summer and the trend continues. It rained ~0.6" on June 26-27. It rained ~3.3" from Monday, June 29- Wednesday, July 1. We left the site mid-day on July 1, because of the rain and there was too much groundwater coming in Site #3 to work.		
Personnel on-site:	<i>EcoGro/Ridgewater:</i> John Arthur, Tony Berry, Eric Dawalt, & Jim Hanssen. <i>Stantec:</i> Oakes Routt		
Equipment on-site:	Komatsu PC 360 w/ hyd. Thumb , Komatsu PC 450		
Material deliveries to project site:	<ul style="list-style-type: none"> 541.9 tons of rock (24"+ dia.) for step pools delivered from Albany quarry (June 25th). 3,000 square yards of 8 oz/SY non-woven geotextile fabric. 		
Work performed the past two weeks:	<ul style="list-style-type: none"> Assisted Aspen with digging their trackhoe out of Site #3 where it had sunk upstream of the check dam (June 23rd). Stantec performed stakeout of step pool section and spot-checked grades at Site#1, #2, and #3 excavation areas. Hauled ~1,100 tons of shot rock from Corps' Disposal area and stockp

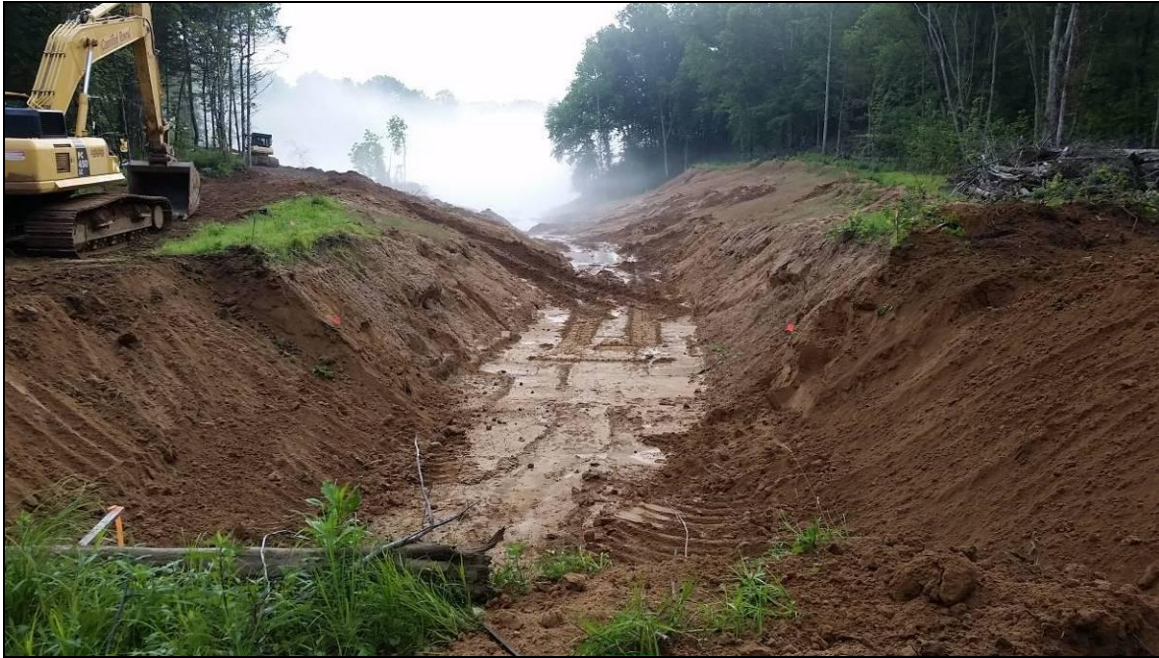
Excavated channel on Site #3 before installation of rock. Picture taken from ~Sta. 154+00 looking downstream.

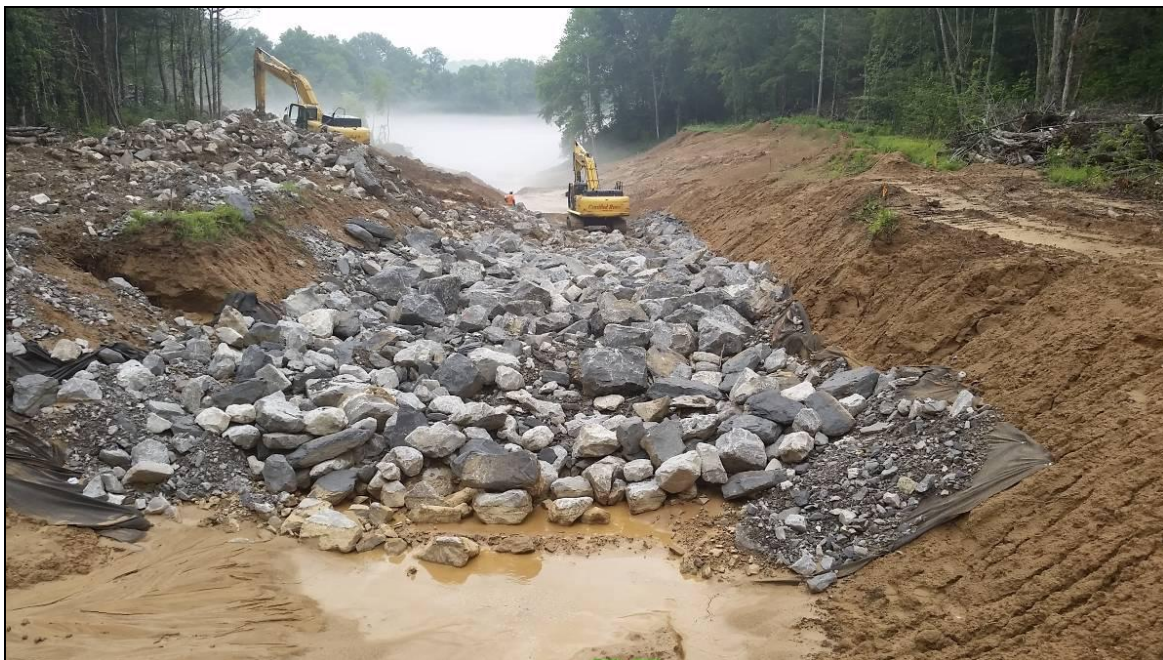
Rock being installed in step pool reach. More rock will be installed on sides as 4' diameter boulders are installed starting at Cumberland River and working upstream. Picture taken from ~Sta. 154+00 looking downstream.

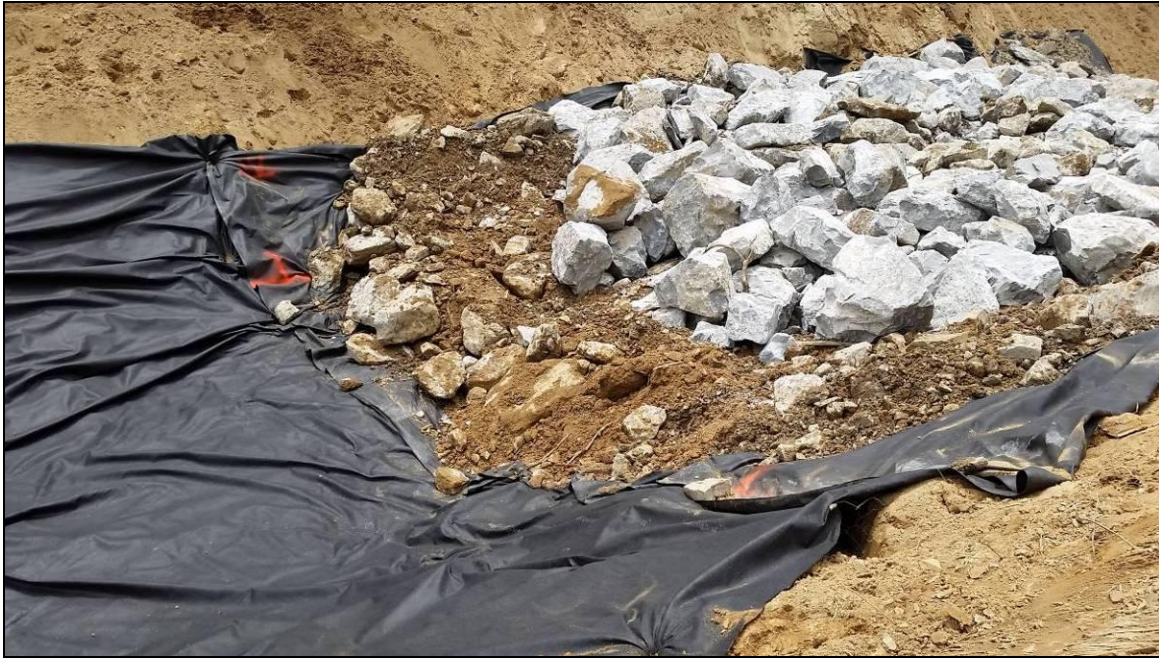
Picture showing geotextile, base rock material (12"-18" deep), and 24"+ dia. rock (two-three feet deep). Picture taken from ~Lt. Sta. 155+00 on left descending bank, looking upstream.
